MACHINE SERVICE BULLETIN NO. 358

SUBJECT: Reversals
LA-5 and LA-6 Models

DATE: July 19, 1940

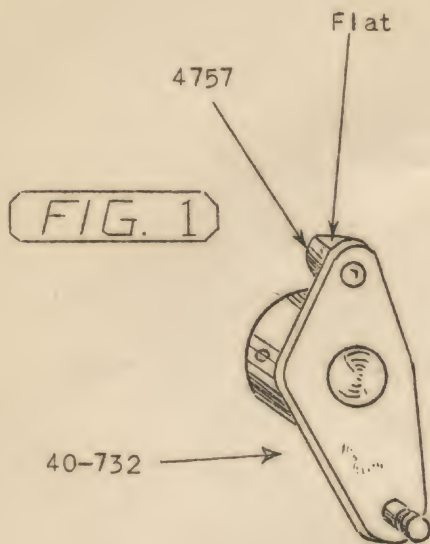
The 4757 stud on the 40-732 and 41-732 crank arm of the carry shaft has a flat side which serves the purpose of retarding the clutch yoke until the proper time for it to move its position from plus to minus or vice versa. See Fig. 1.

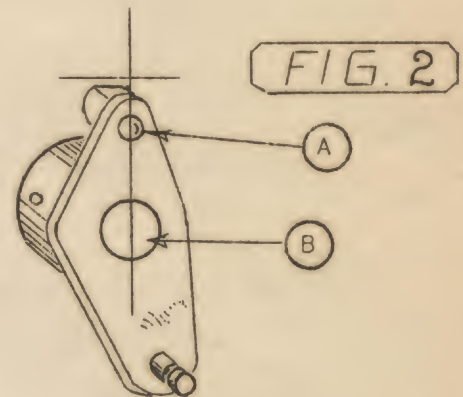
If reversal trouble is encountered, inspect the 40-732 crank arm to determine if the flat of the 4757 stud is located at a right angle to a line drawn through the center of shaft (B) and rivet (A). See Figure 2. If for some reason the flat is positioned otherwise, remove the 40-732 or 41-732 and while held in a vise, turn the stud to the proper position with pliers, after which retighten the rivet or replace the 40-732 or 41-732 with another.

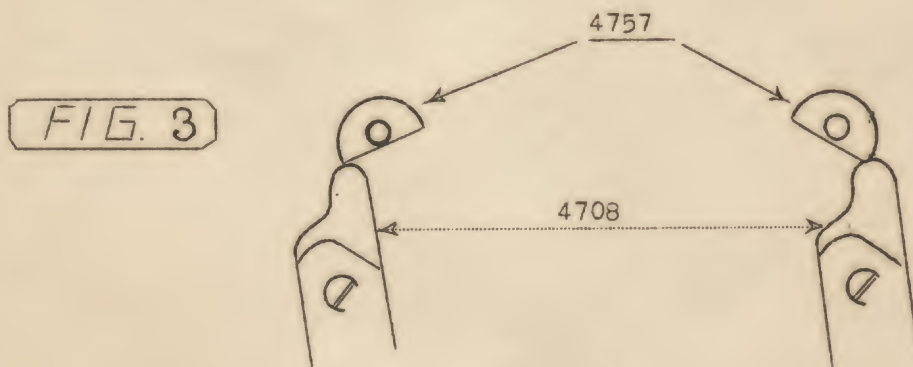
The two edges of this flat side move the clutch yoke into the plus or minus position according to the direction the machine starts to cycle. As the 40-732 or 41-732 turns, the edge of the flat side will contact the center point of the top of the 4708 blank and cause the yoke to move into the position desired (provided the 4708 is correctly adjusted) and the flat of the 4757 stud will prevent movement of the yoke in the wrong direction if it should receive a rebound from some source. See Figures 3 and 4.
